TECHNICAL NOTE 3512

EFFECT OF SOME SELECTED HEAT TREATMENTS ON THE
OPERATING LIFE OF CAST HS-21 TURBINE BLADES

By Francis J. Clauss, Floyd B. Garrett, and
John W. Weeton

Lewis Flight Propulsion Laboratory
Cleveland, Ohio

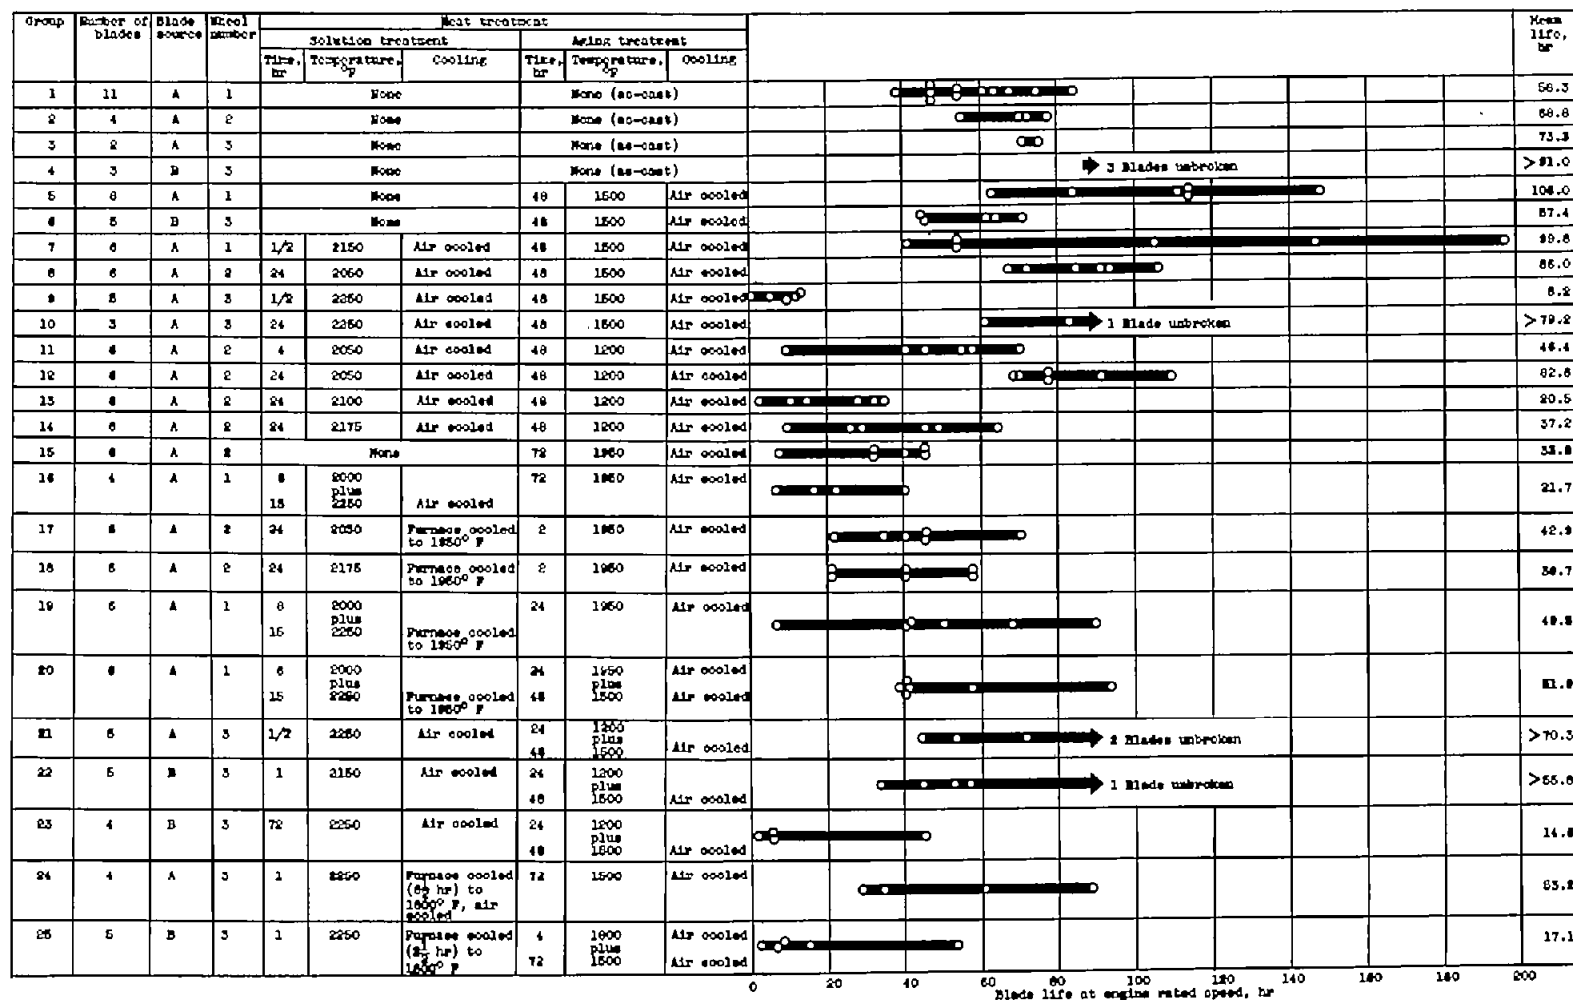
Figure 1. - Blade heat treatments and engine results.

Heat treatments. - The heat treatments studied are listed in figure 1. As-cast blade groups (groups 1 to 4) were included in the three wheels as standards for comparison. This was done so that slight differences in wheel operating characteristics, which might exist despite the careful control of blade temperatures and stresses, could be taken into account in making comparisons.

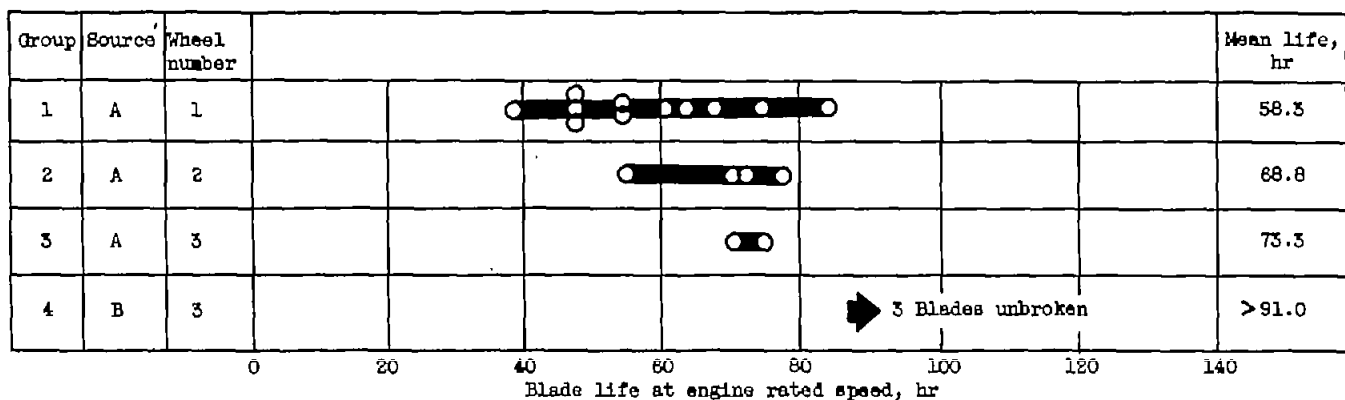
Figure 2. - Comparison of blade lives run in as-cast condition in several wheels.

As-cast blades (fig. 2). - Blades from source A tested in the as-cast condition in the second and third wheels (groups 2 and 3) showed an increase of about 22 percent in mean life over the same blades run in the first wheel (group 1). Statistical analysis shows that there were minor changes in operating conditions between the time of the first wheel and the second and third wheels at the 80 percent confidence level. This is less than what is ordinarily considered significant, and the three wheels can be said to have operated almost identically.

As-cast blades from source B tested in the third wheel (group 4) performed better than blades from source A run in the same condition and in the same wheel (group 3). Running of the third wheel was stopped after 91.0 hours, at which time none of the as-cast blades from source B had failed. The mean life of these blades would therefore be at least 91.0 hours. This is 17.7 hours, or 24 percent, better than the mean life of the as-cast blades from source A run in the same wheel.

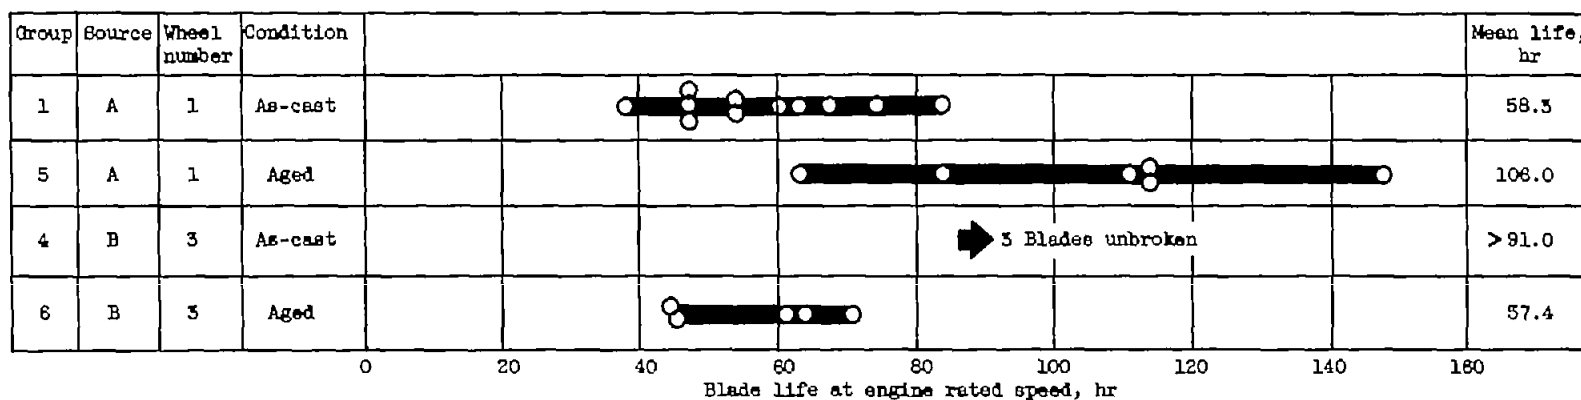
Figure 3. - Effect of aging 48 hours at 1500° F on life of as-cast blades.

Aging alone (fig. 3). - Aging 48 hours at 1500° F (group 5) increased the mean life of blades from source A by about 80 percent over the as-cast condition (group 1). It also improved the time to first failure but increased the scatter in performance. Blades from source B given this same aging treatment (group 6) had a lower operating life than as-cast blades from this source (group 4).

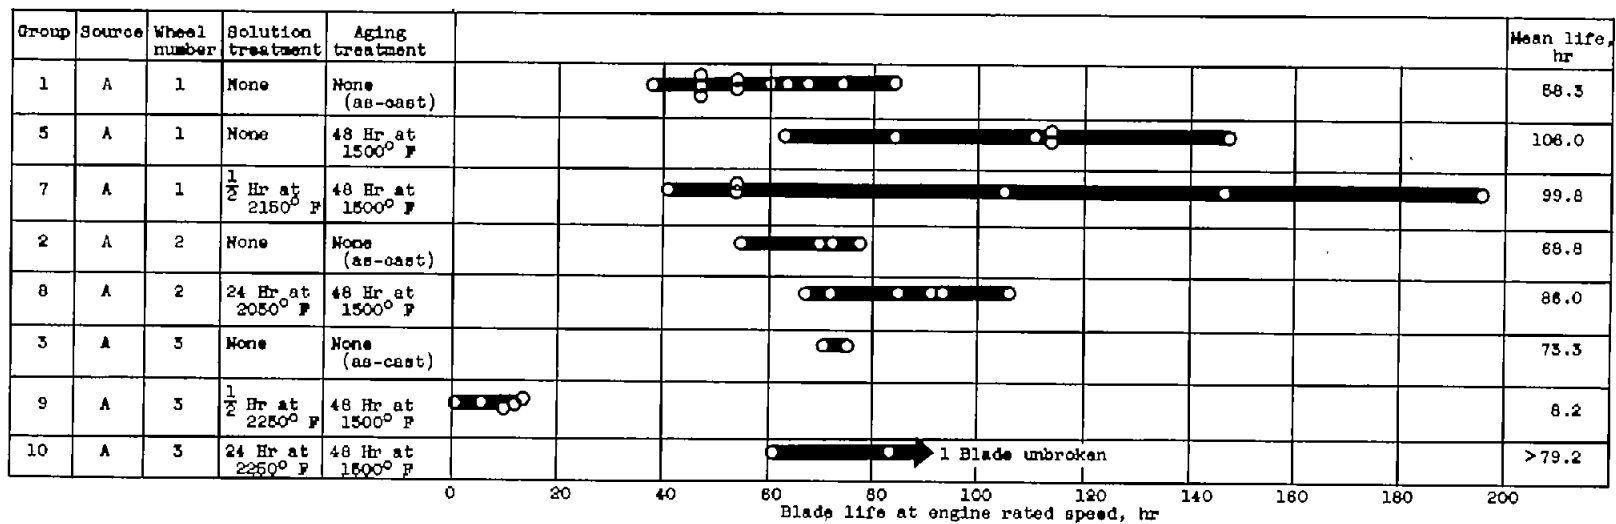
Figure 4. - Effect of various solution treatments before aging 48 hours at 1500° F.

The effect of various solution treatments followed by aging 48 hours at 1500° F is shown in figure 4. Solution treating for 1/2 hour at 2150° F followed by this aging (group 7) increased the mean life about 70 percent over that of the as-cast blades run in the first wheel. The time to first failure was practically unchanged and the over-all scatter was increased. While the improvement in mean life was less than that obtained by aging alone (group 5), the last blades to fail in group 7 ran for encouragingly long times. The use of solution treatment would be justified if the early failures were eliminated. Examination revealed eutectic melting in several of the blades of group 7 which might have caused the early failures.

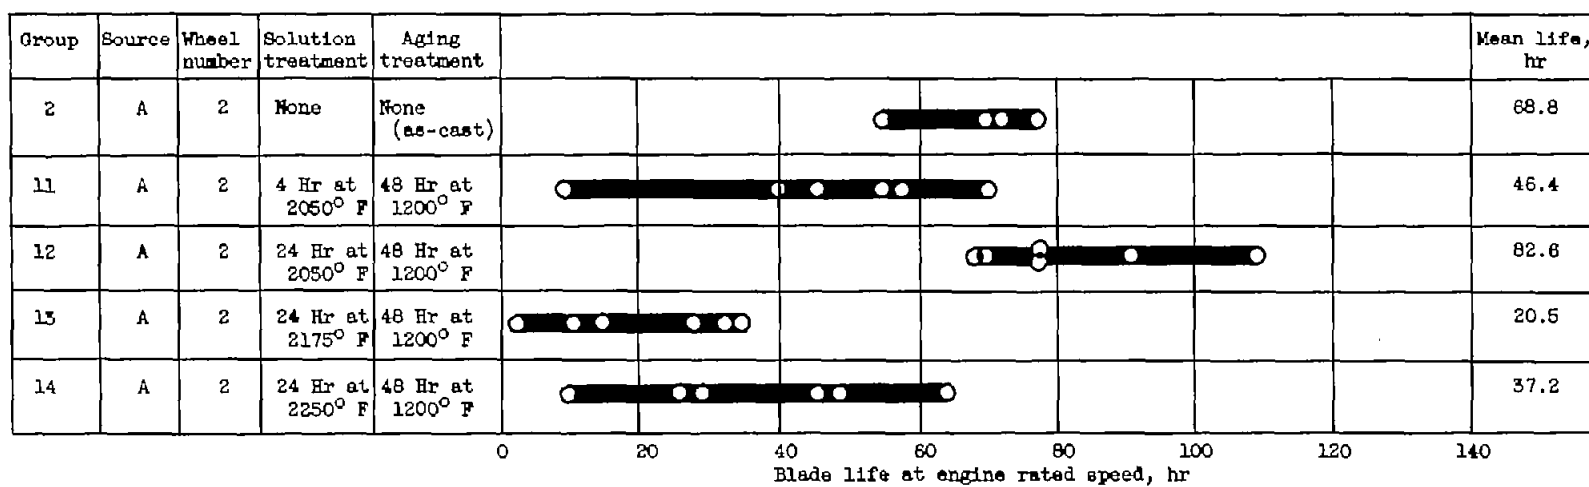
Figure 5. - Effect of various solution treatments before aging 48 hours at 1200° F.

The effect of various solution treatments followed by aging 48 hours at 1200° F is shown in figure 5. These treatments (groups 11 to 14) did not improve the performance as expected from the study of stress-rupture life on wrought material (ref. 7). Of the various solution treatments used before aging at 1200° F, only 24 hours at 2050° F (group 12) gave a better mean life than that of the as-cast blades (group 2). This improvement was only slight and less than could be obtained by other heat treatments.

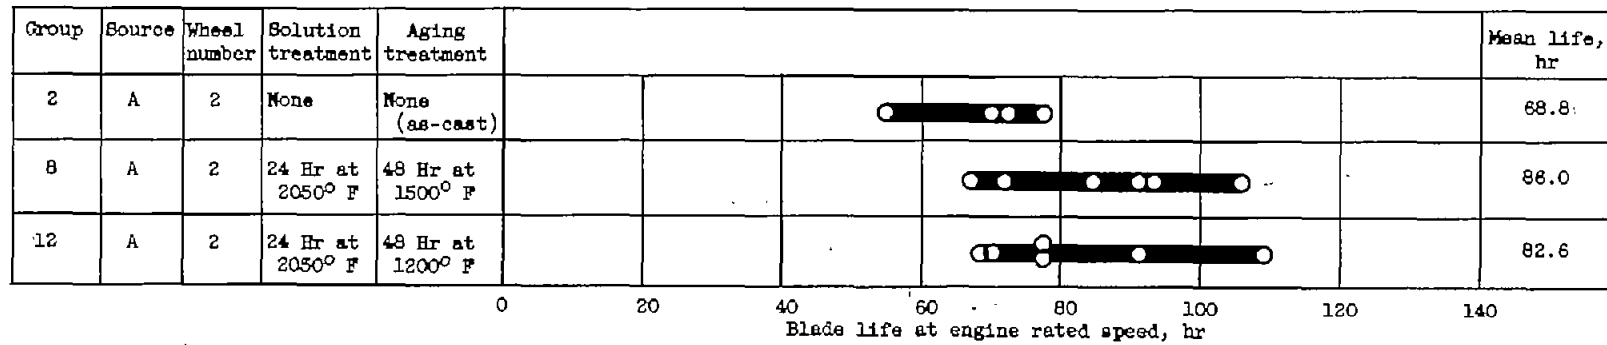
Figure 6. - Comparison of aging at 1500° and 1200° F after solution treatment.

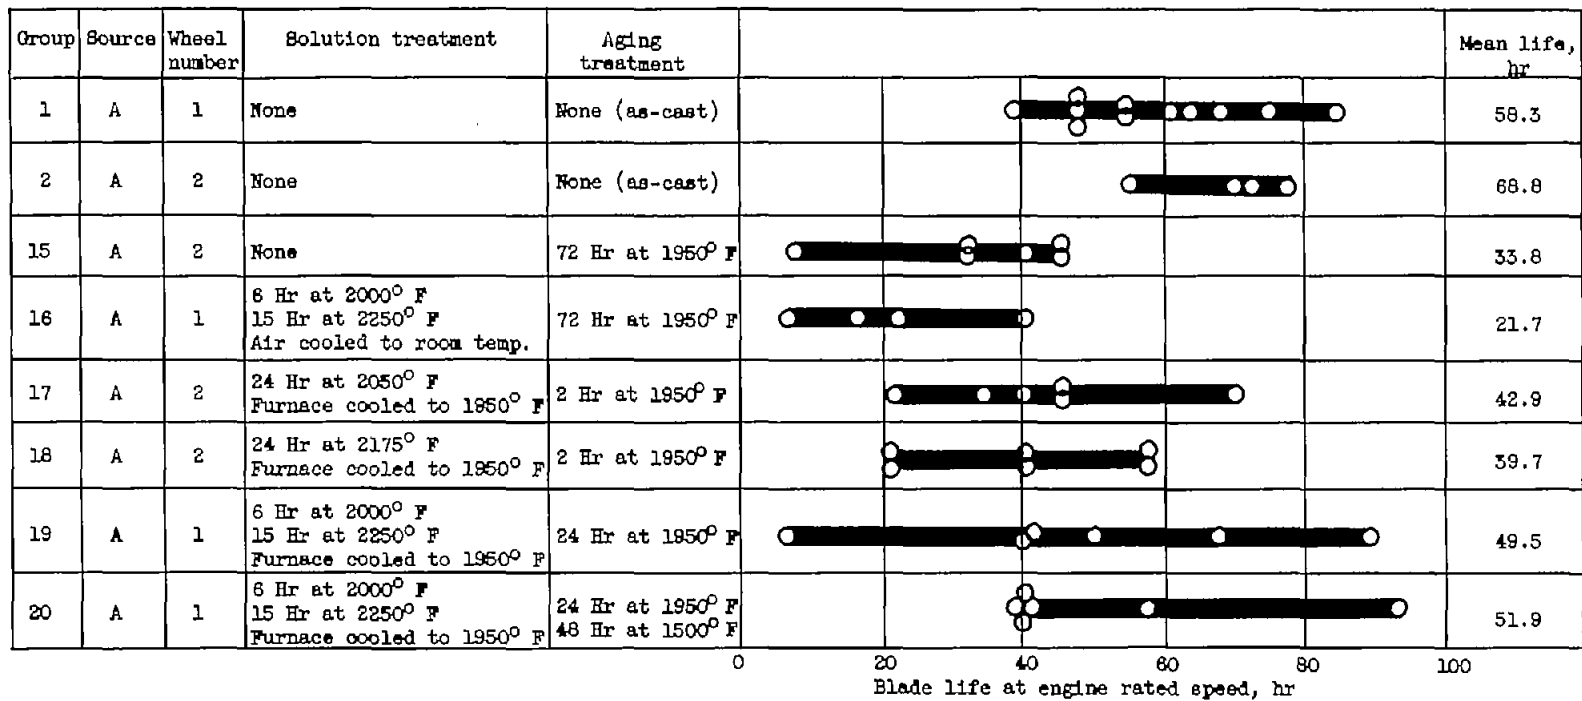
Figure 7. - Effect of aging or isothermal transformation at 1950° F.

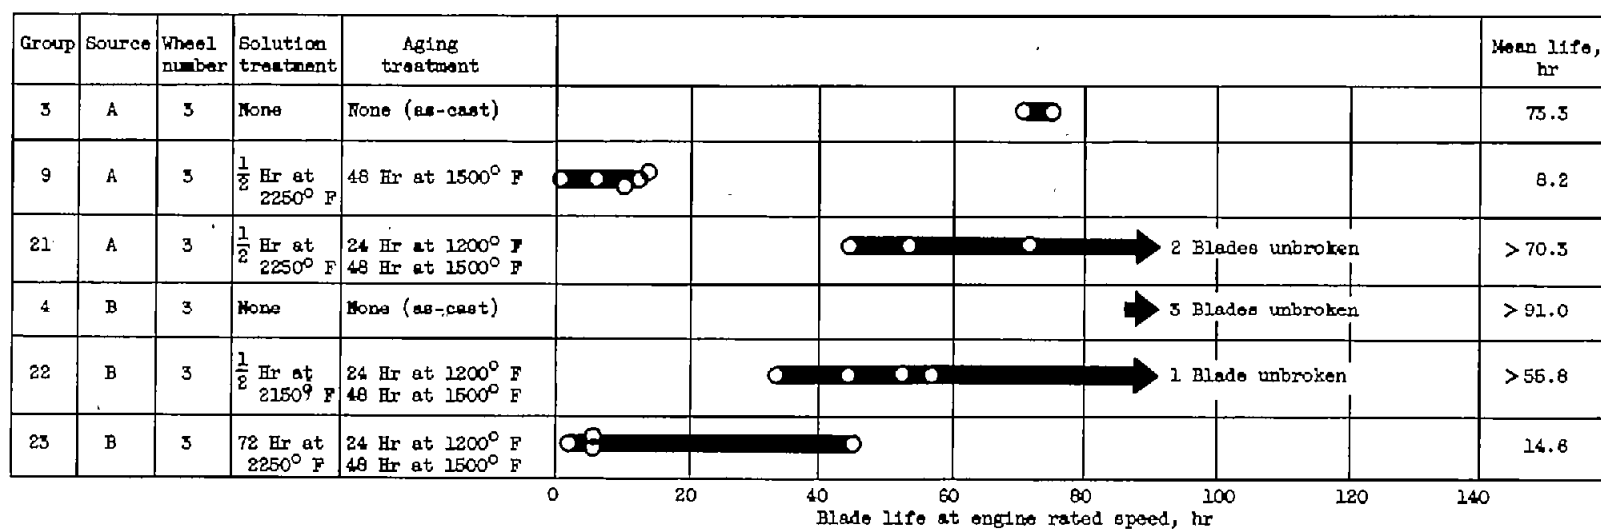
Figure 8. - Effect of double-aging heat treatments.

Double aging (fig. 8). - Double-aging treatments, in which blades were solution treated and aged 24 hours at 1200° F plus 48 hours at 1500° F (groups 21 to 23) failed to increase blade life. None of the groups showed a significant improvement in performance over that of the as-cast condition. Note that double aging after 1/2 hour at 2250° F (group 21) greatly increased the performance over that of the same solution treatment followed by a single age at 1500° F (group 9). The long-time solution treatment used in group 23 gave the poorest results of the double-aged groups.

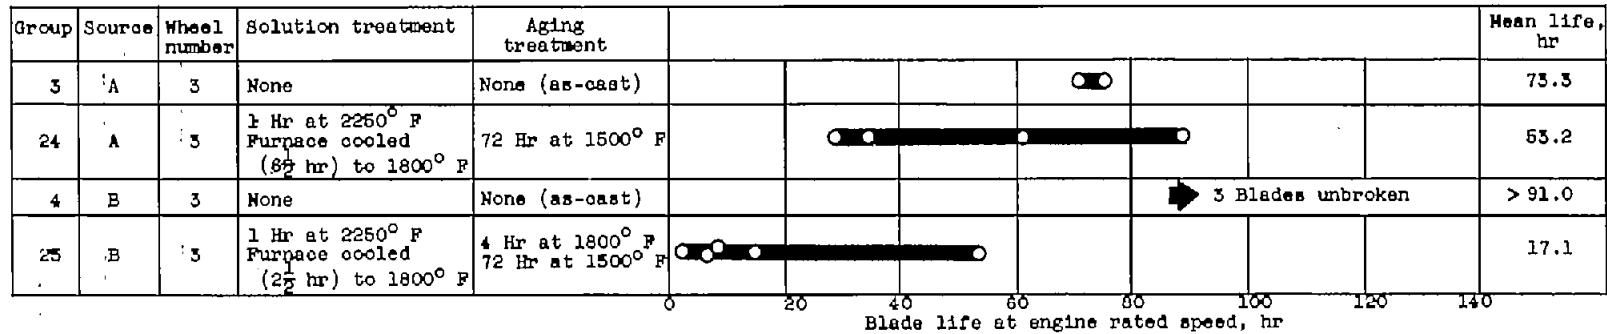
Figure 9. - Effect of treatment described in reference 5.

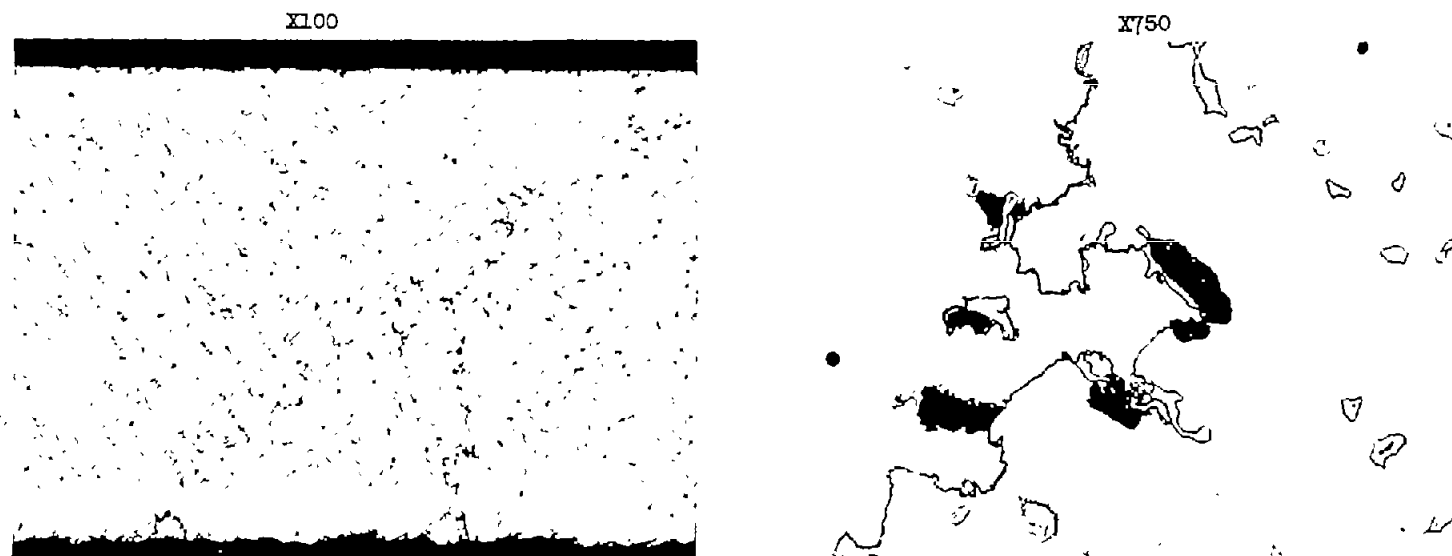
(a) Typical structure in small sections of blades.

(b) Typical structure in large sections of blades.

Figure 10. - Microstructure of cast BS-21 turbine blades from source A in as-cast condition (groups 1 to 3).
Electrolytically etched in 5 percent aqua regia.

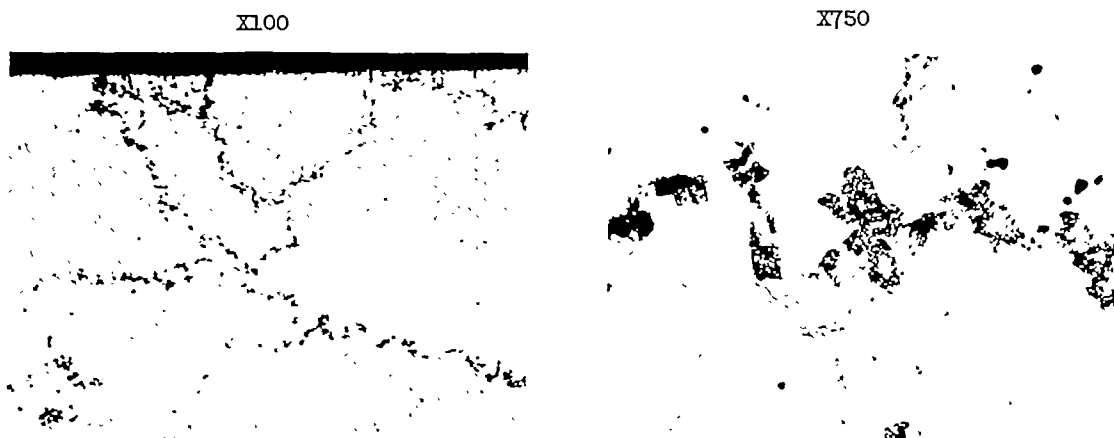
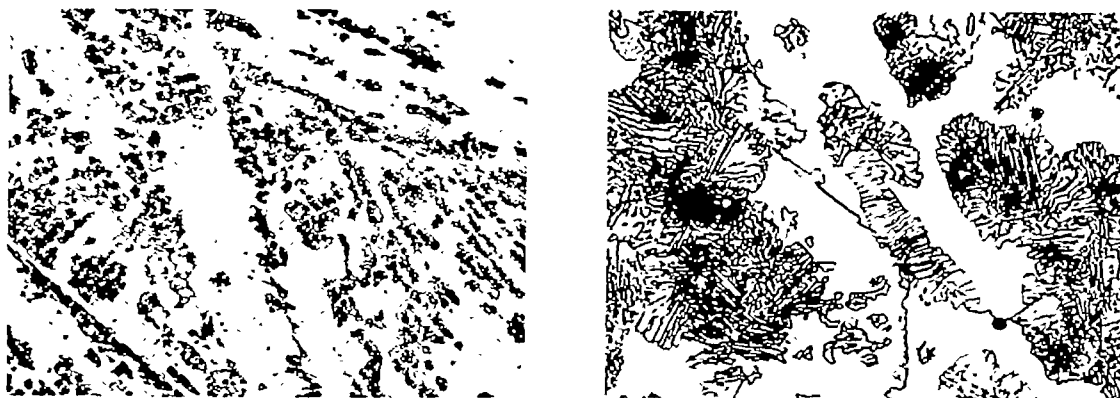
(a) Typical structure in small sections of blades.

(b) Typical structure in large sections of blades.

(c) Heavy concentration of pearlite precipitation.

Figure 11. - Microstructure of cast HS-21 turbine blades from source B in as-cast condition (group 4). Electrolytically etched in 5 percent aqua regia.

In the production blades used in the present investigation, the control over the casting conditions was limited to that employed in commercial practice. Thus, variations in the microstructure of corresponding sections taken from different blades were found to occur. Also, the microstructure of a single blade varied with the location in the blade, being influenced by the relative rates of cooling of different blade sections due to differences in size and position. These variations were mainly differences in the amount, size, and distribution of the carbide precipitates. These carbides were present either as separate islands occurring interdendritically in the matrix or as a pearlite type of precipitation along grain boundaries. The major difference between the microstructures of blades from sources A and B was the occurrence of a greater amount of pearlitic precipitation and larger interdendritic areas in the blades from source B.

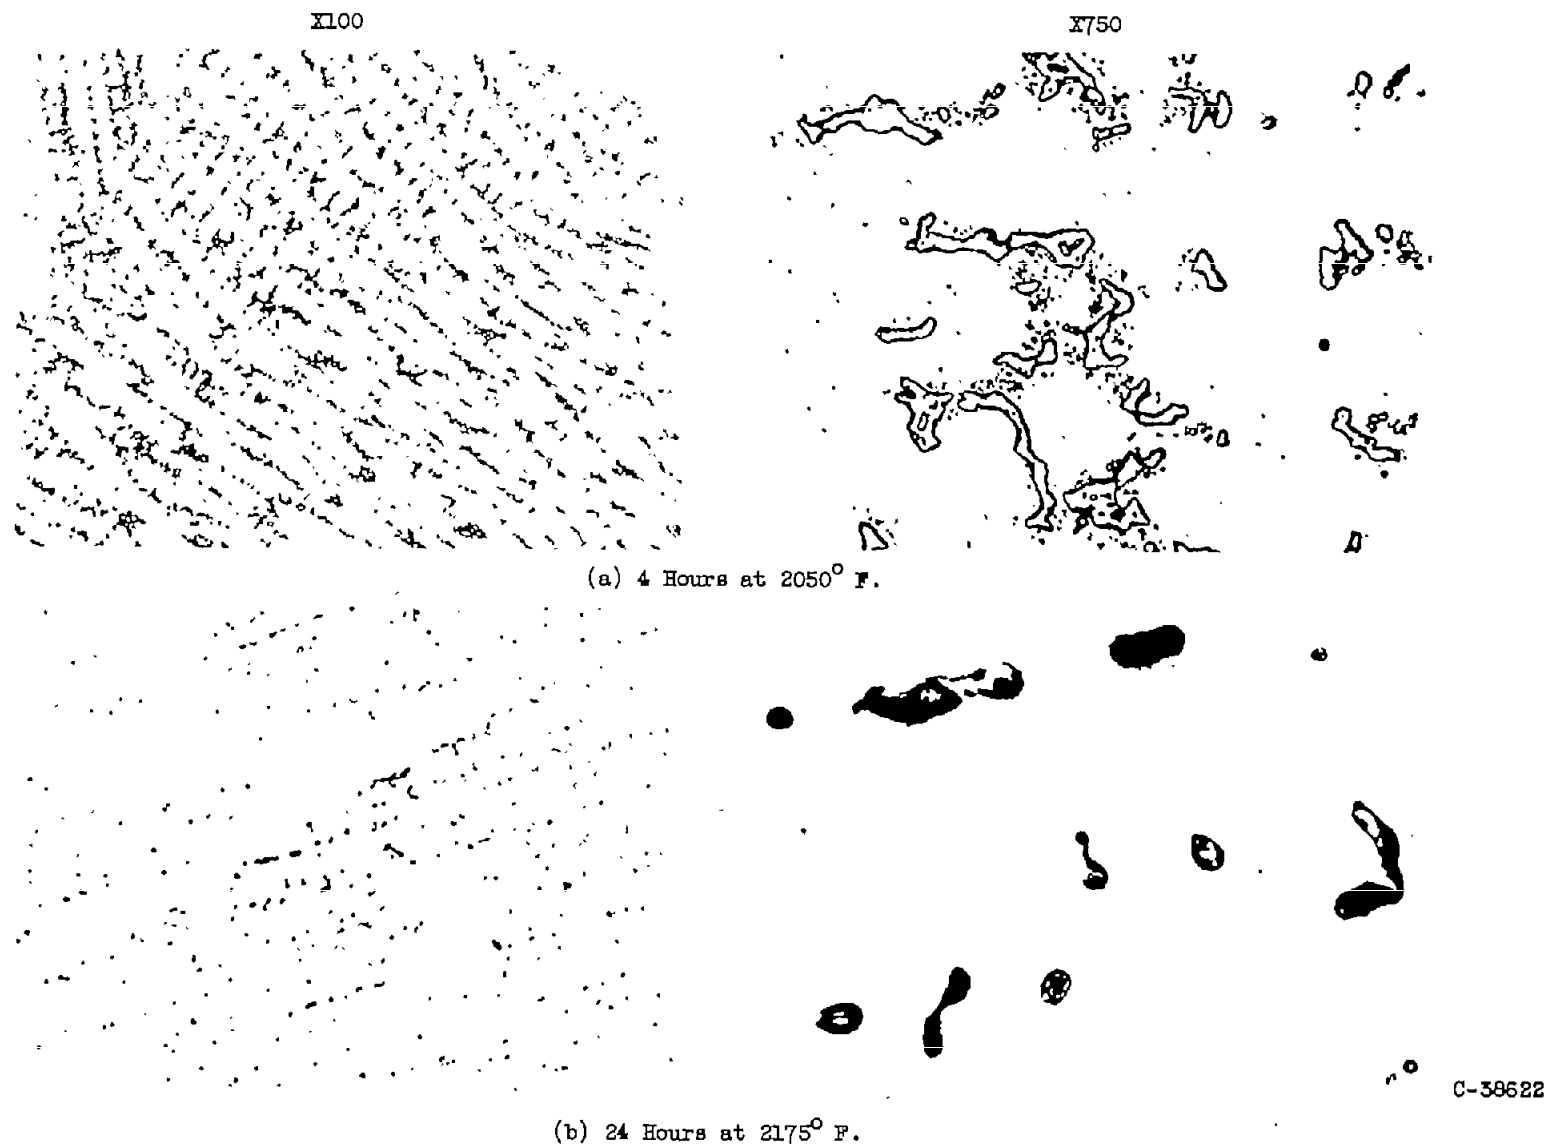
Figure 12. - Response of cast HS-21 turbine blades from source A to solution treatment. Electrolytically etched in 5 percent aqua regia.

Solution treating. - The degree of solution treatment obtained by holding the cast blades at temperatures of 2050° F and above is shown in figures 12 and 13. Four hours at 2050° F was found to be insufficient to dissolve all the carbides into the matrix (figs. 12(a) and 13(a)). Increasing the time and temperature to 24 hours and 2175° F, respectively (figs. 12(b) and 13(b)), dissolves more of the carbides, particularly with blades from source A. However, it also results in an increase in the number and severity of the partial voids which probably are due to eutectic melting. These voids occur in areas formerly occupied by interdendritic carbides. After 24 hours at 2250° F, solution of the carbides is complete, but the occurrence of eutectic melting is especially severe, particularly in blades from source B (fig. 13(c)). There was also some grain boundary melting in this case.

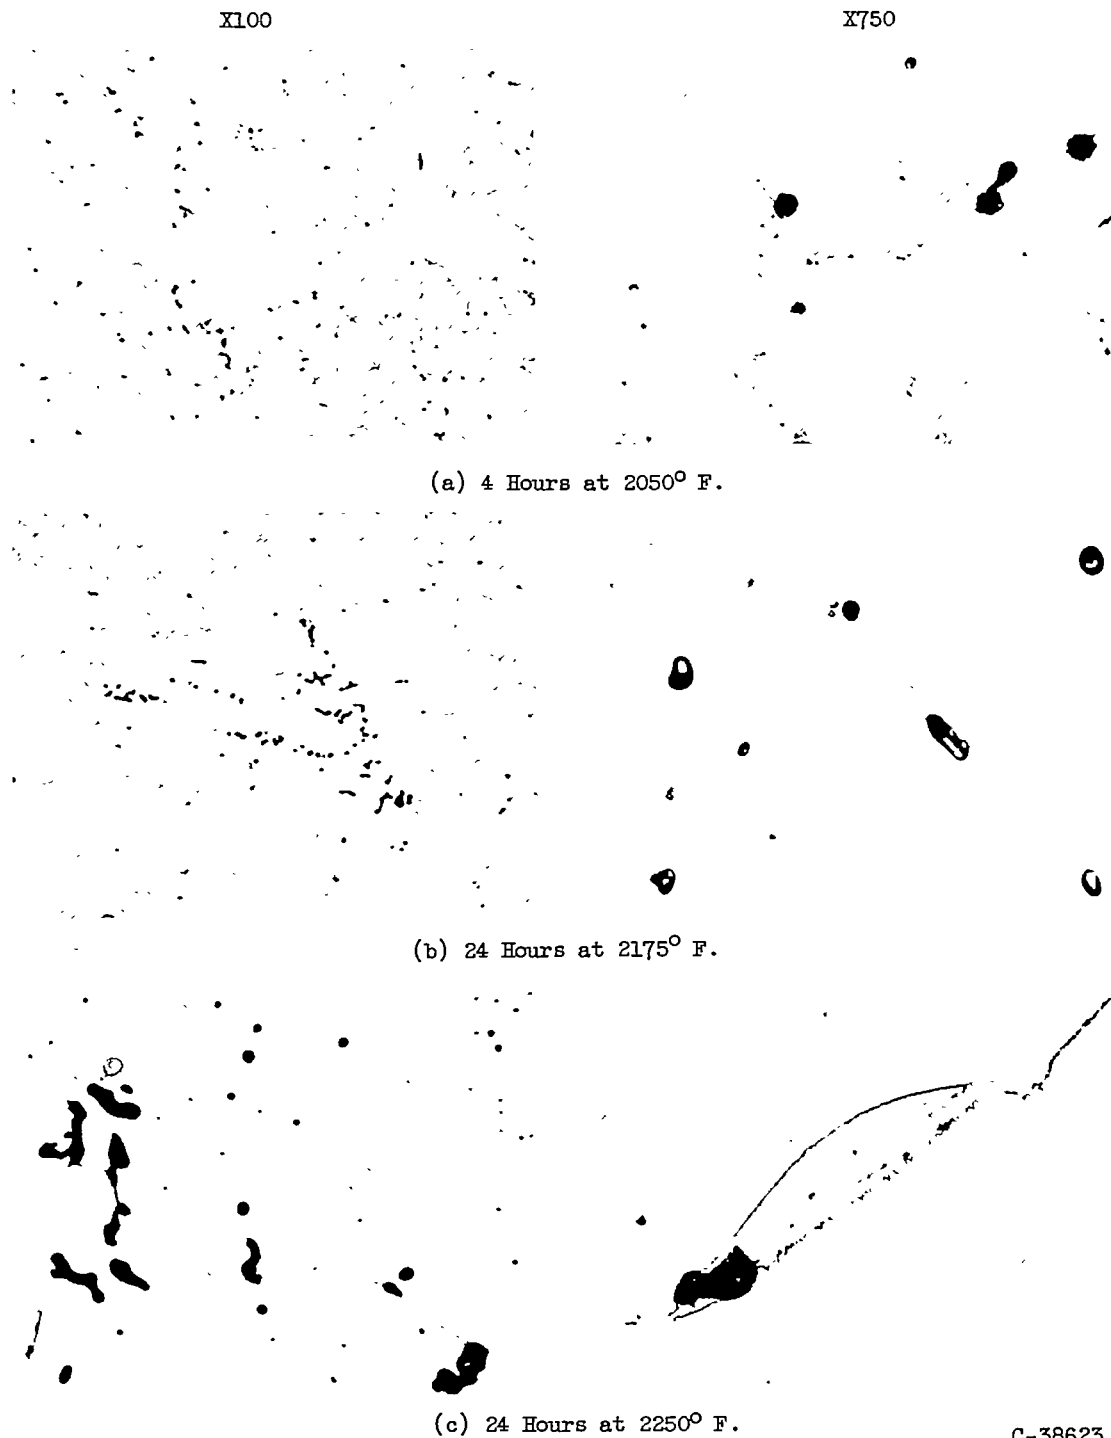
Figure 13. - Response of cast HS-21 turbine blades from source B to solution treatment.
Electrolytically etched in 5 percent aqua regia.

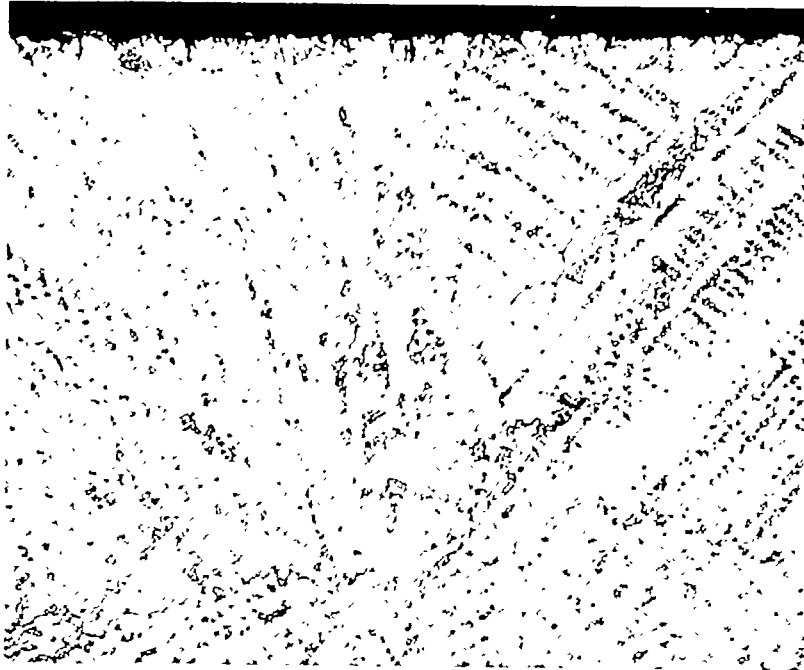
Figure 14. - Recrystallized layer of small grains at edge of heat-treated blade from group 17 (solution treated 24 hr at 2050° F, furnace cooled to 1950° F, aged 2 hr at 1950° F, and air cooled). Electrolytically etched in 5 percent aqua regia.

Solution treatment generally resulted in a recrystallized skin of small grains at the leading and trailing edges of the blades. An example of this in blades before operation is shown in figure 14. A decrease in the amount of carbide precipitation at the surface was noted in several cases.

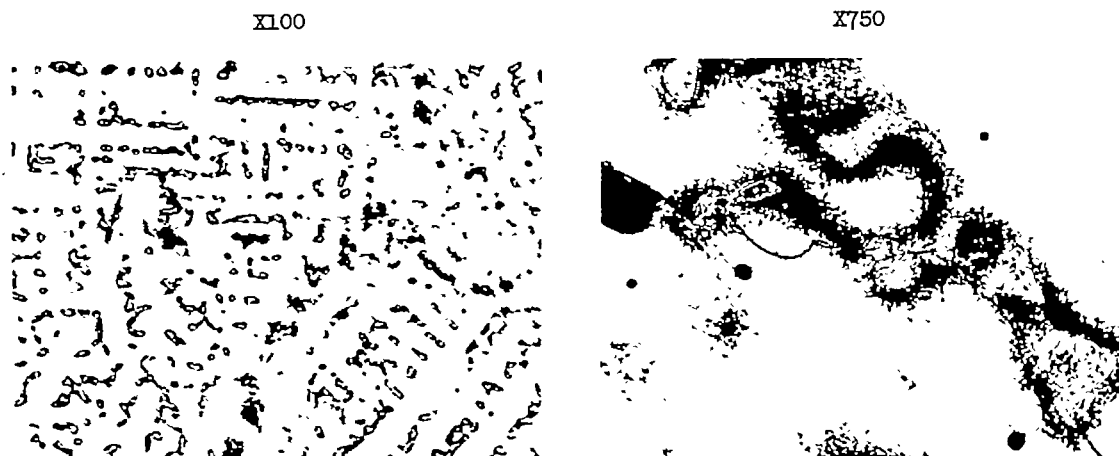
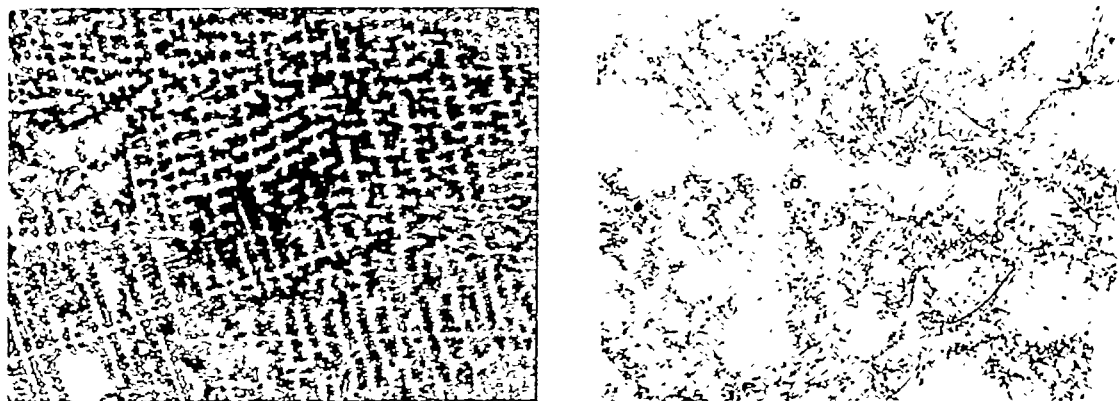
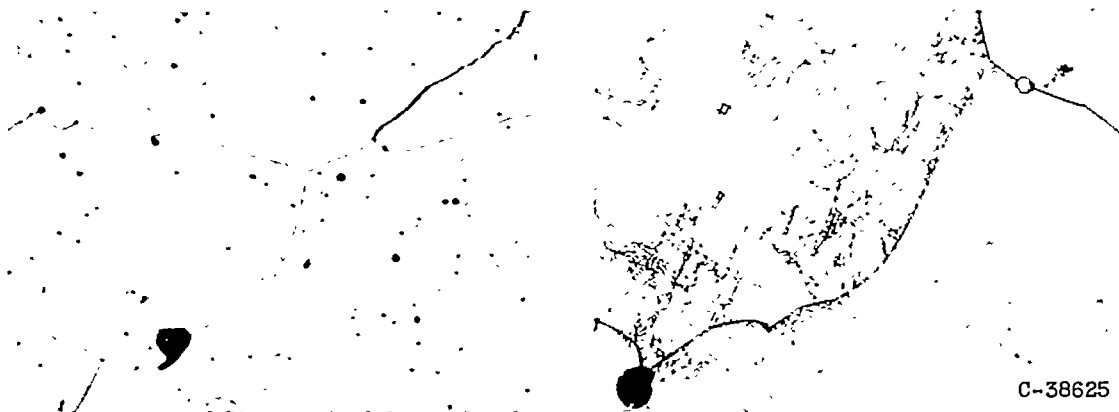
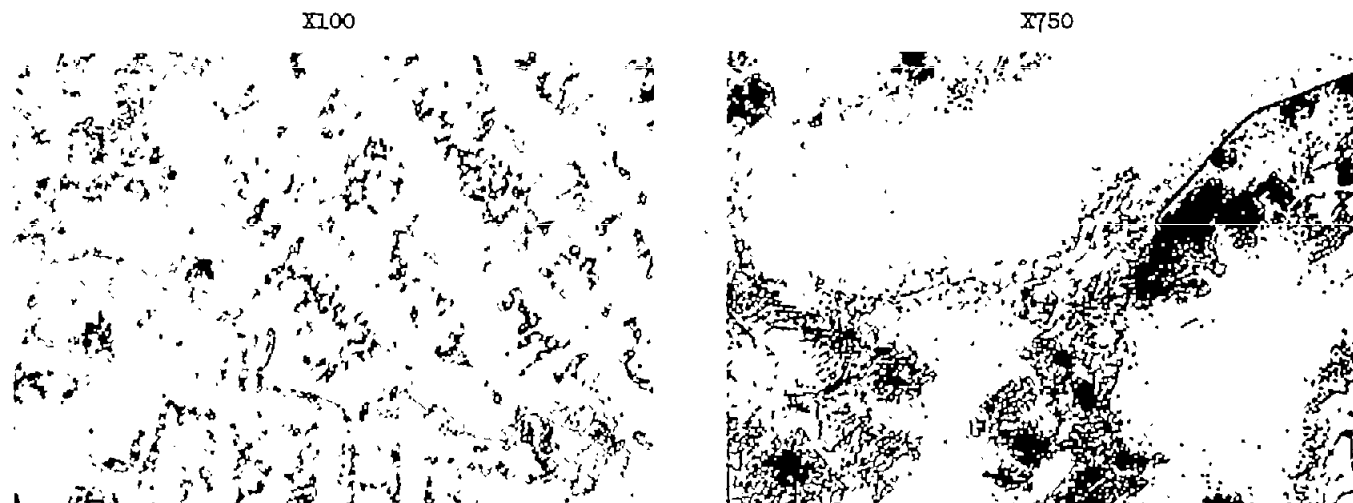
(a) No prior solution treatment (groups 5 and 6).

(b) Solution treated 1/2 hour at 2150° F and air cooled prior to aging (group 7).

(c) Solution treated 1/2 hour at 2250° F and air cooled prior to aging (group 9).

Figure 15. - Microstructure of cast HS-21 turbine blades after aging 48 hours at 1500° F. Electrolytically etched in 5 percent aqua regia.

(d) Solution treated 24 hours at 2050° F and air cooled prior to aging (group 8).

(e) Solution treated 24 hours at 2250° F and air cooled prior to aging (group 10).

Aging and effects of prior solution treatments on aged structures. - Aging the cast blades at 1500° F resulted in the formation of fine particles of precipitate clustered about the primary carbides. This is shown in figure 15(a), for which the aging time was 48 hours. Different solution treatments followed by this same aging treatment gave the microstructures shown in figures 15(b) to (e). In general, increasing the time or temperature of solution treatment gave a wider distribution of carbide precipitation during aging at 1500° F. Figure 16 shows the microstructure after solution treatment and aging at 1200° F. Except for small patches of pearlite that are sometimes observed along the grain boundaries, aging at 1200° F has produced no apparent change in the solution-treated structure.

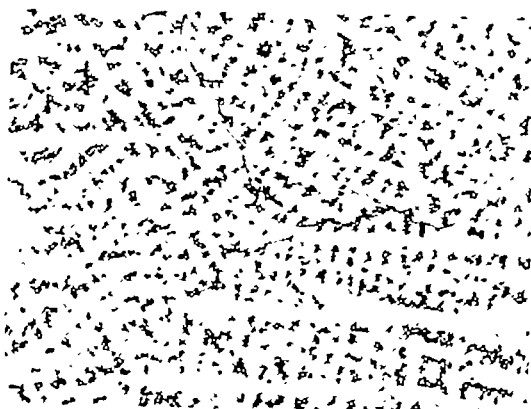
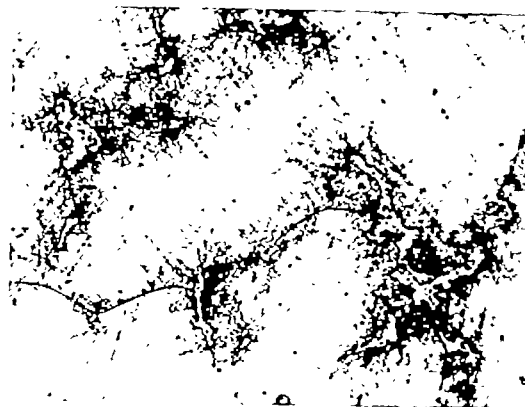
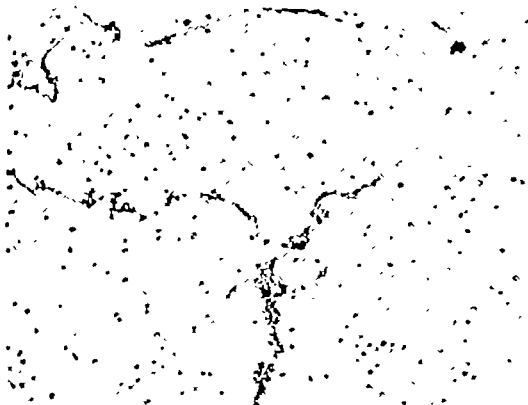
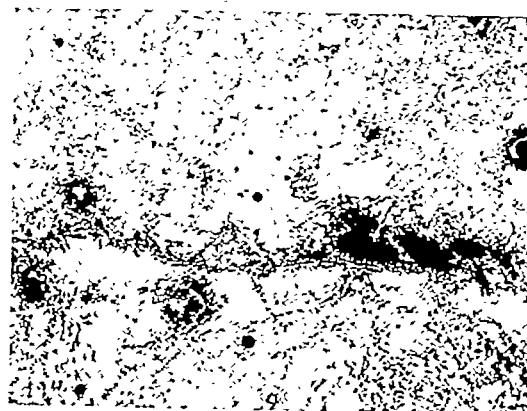
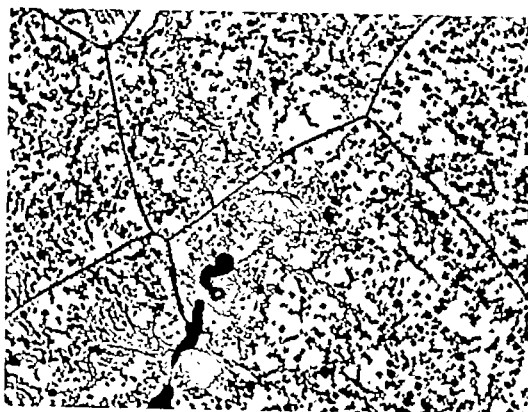
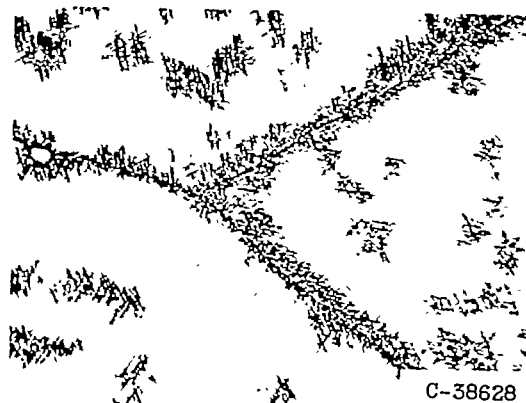
(a) Solution treated 1 hour at 2150° F and air cooled prior to aging (group 22).

(b) Solution treated 1/2 hour at 2250° F and air cooled prior to aging (group 21).

(c) Solution treated 72 hours at 2250° F and air cooled prior to aging (group 23).

Figure 17. - Microstructure of cast HS-21 turbine blades after double aging 24 hours at 1200° F plus 48 hours at 1500° F. Electrolytically etched in 5 percent aqua regia.

The microstructures after double aging, using a 24-hour age at 1200° F between solution treating and aging at 1500° F, are shown in figure 17 for three conditions of solution treatment. One-half hour at 2250° F (fig. 17(b)) gave a wider distribution of precipitation during aging than 1 hour at 2150° F (fig. 17(a)), while 72 hours at 2250° F gave a heavy Widmanstätten type of precipitate (fig. 17(c)).

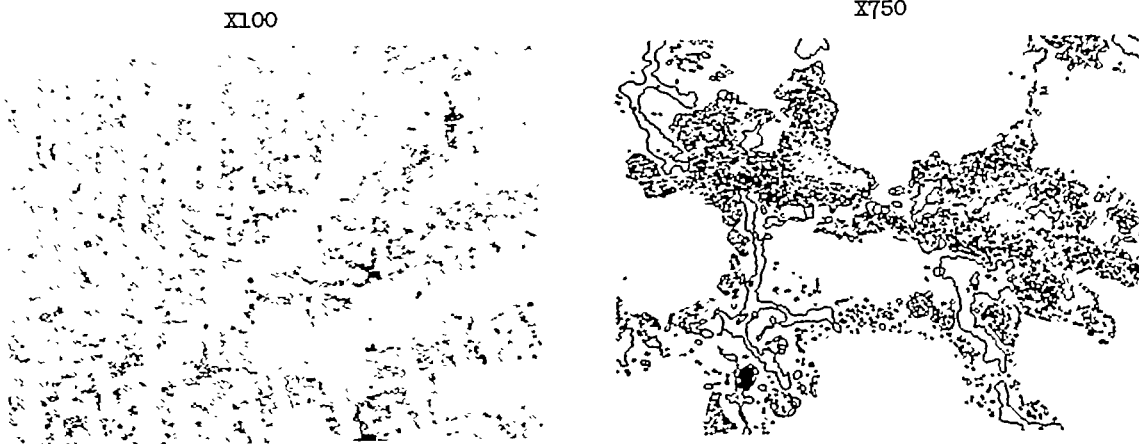
Figure 18. - Microstructure of cast HS-21 turbine blades after aging 72 hours at 1950° F (group 15). Electrolytically etched in 5 percent aqua regia.

An aging temperature of 1950° F was too high to cause significant precipitation, whether used as a straight aging treatment or preceded by solution treatment. In the first case (fig. 18), aging at 1950° F dissolved some of the as-cast carbides, particularly in the grain boundaries. There was also a general tendency to spheroidize the carbide particles.

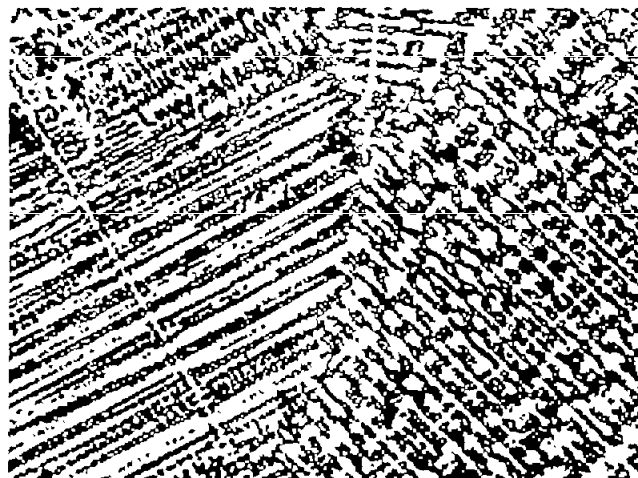
Figure 21. - Microstructure of cast HS-21 blade operated 77.8 hours at rated speed without previous heat treatment. Electrolytically etched in 5 percent aqua regia.

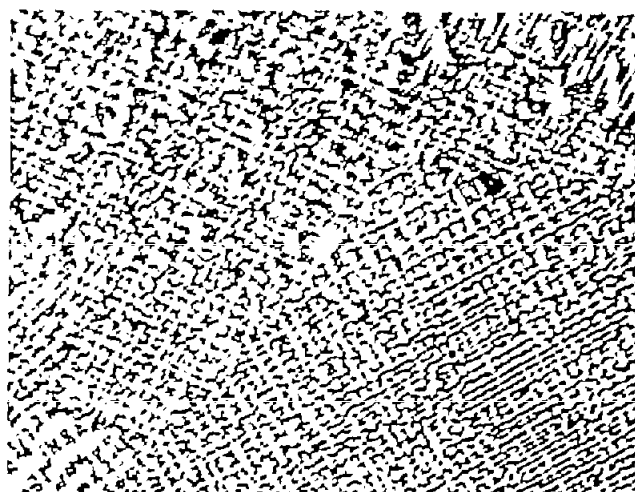
Figure 22. - Microstructure of cast HS-21 blade aged 48 hours at 1500° F after operation for 114.2 hours. Electrolytically etched in 5 percent aqua regia.

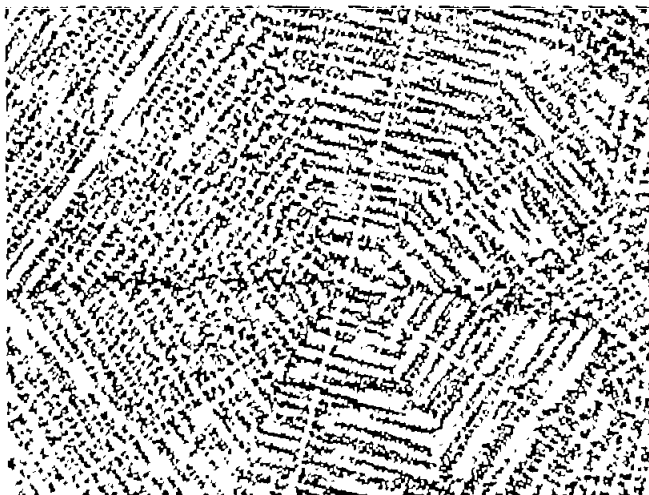
Figure 23. - Microstructure of cast HS-21 turbine blade solution treated 1/2 hour at 2150° F, air cooled, and aged 48 hours at 1500° F after operation for 196.13 hours at rated speed (group 3). Electrolytically etched in 5 percent aqua regia.

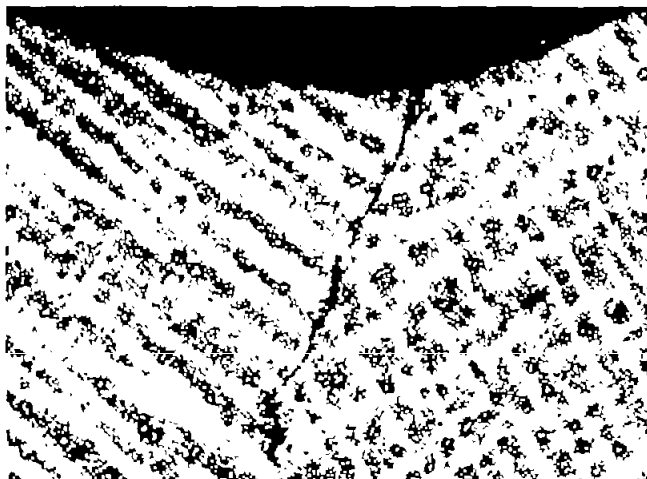
Figure 24. - Microstructure of cast HS-21 turbine blade solution treated 24 hours at 2250° F, air cooled, and aged 48 hours at 1500° F after operation 60.75 hours at rated speed (group 18). Electrolytically etched in 5 percent aqua regia.

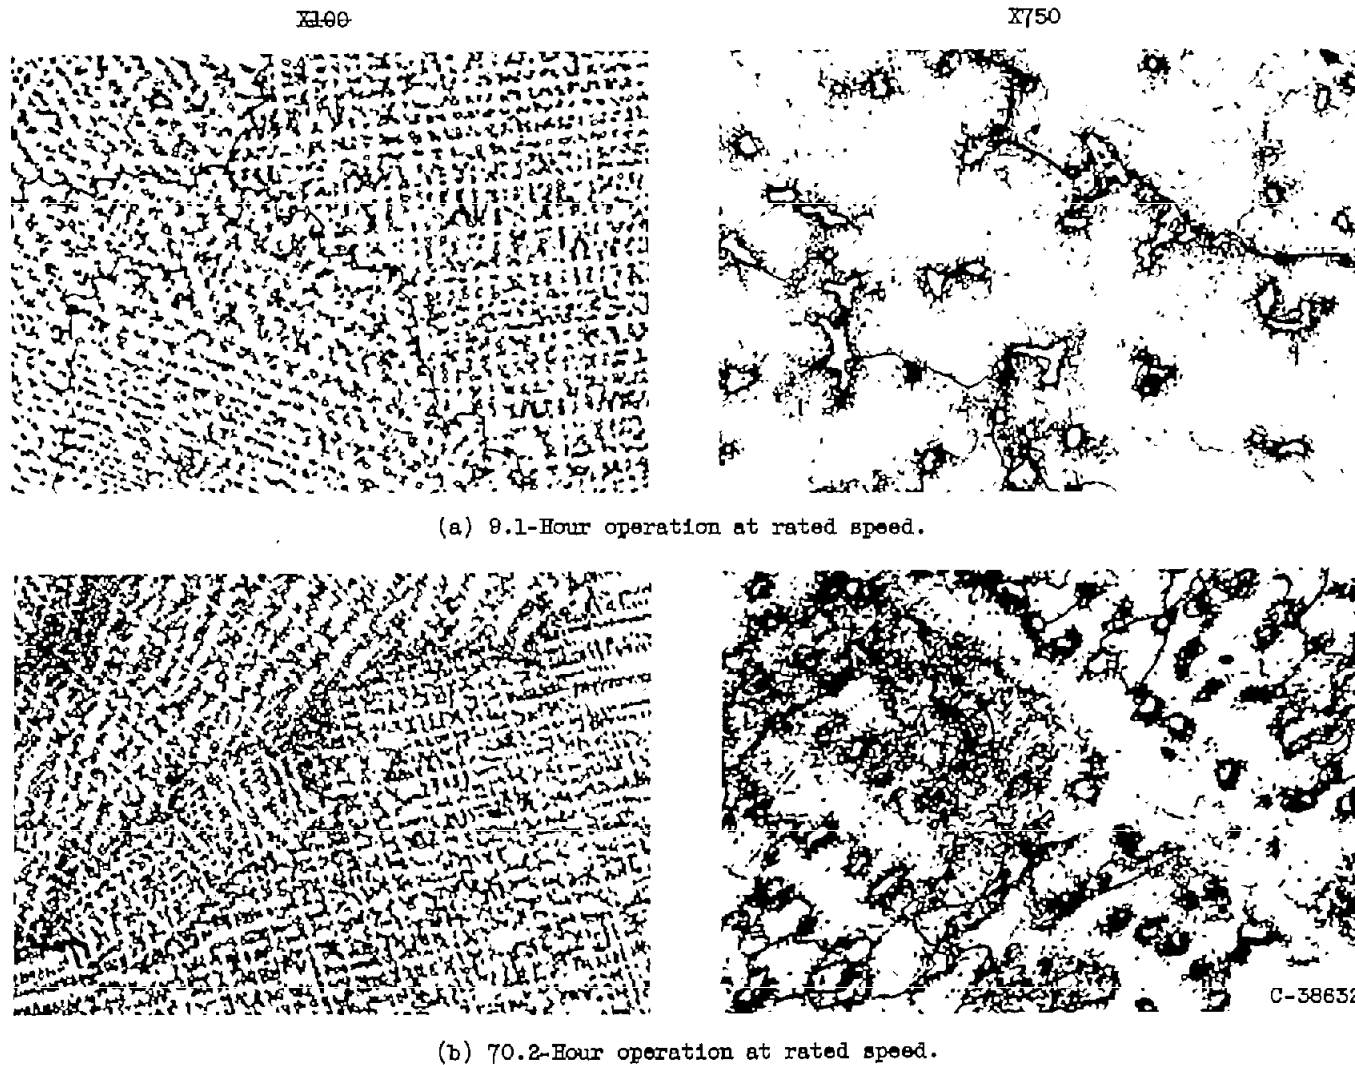
Figure 25. - Microstructure of cast HS-21 turbine blade solution treated 4 hours at 2050° F, air cooled, and aged 48 hours at 1200° F after operation in engine (group 11). Electrolytically etched in 5 percent aqua regia.
